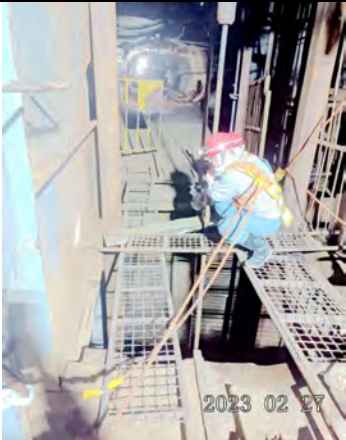
180	GX-B1598/21-6-23006	2023. 4. 14	实测钢丝绳有效截面积损失百分比最大为4.64%，小于5%为正常。 。

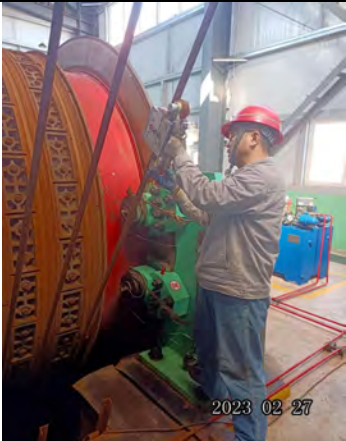
181	GX-B1598/21-6-23007	2023. 4. 14	实测钢丝绳有效截面积损失百分比最大为2.64%，小于5%为正常。 。

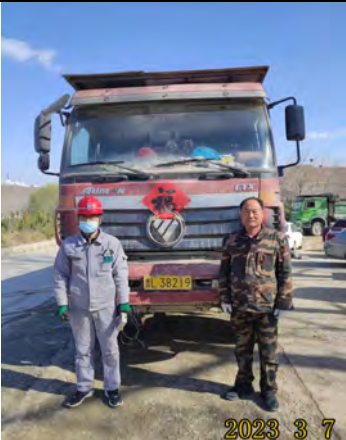
182	GX-B1423/20-6-23201	2023. 4. 16	合格

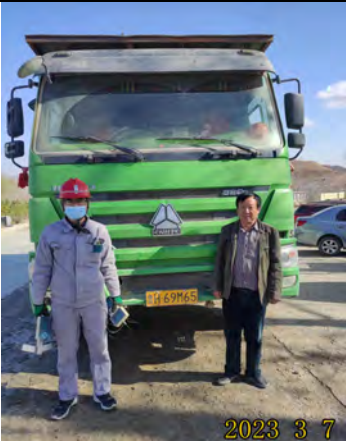
183	GX-B1423/20-6-23202	2023. 4. 16	合格

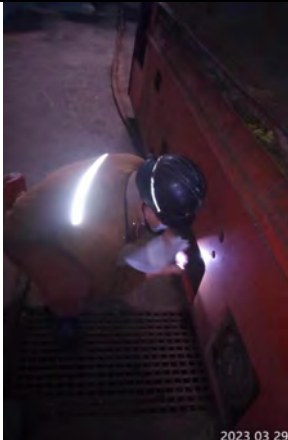
214	GX-B1517/20-6-23001	2023/4/20	综合判定：合格

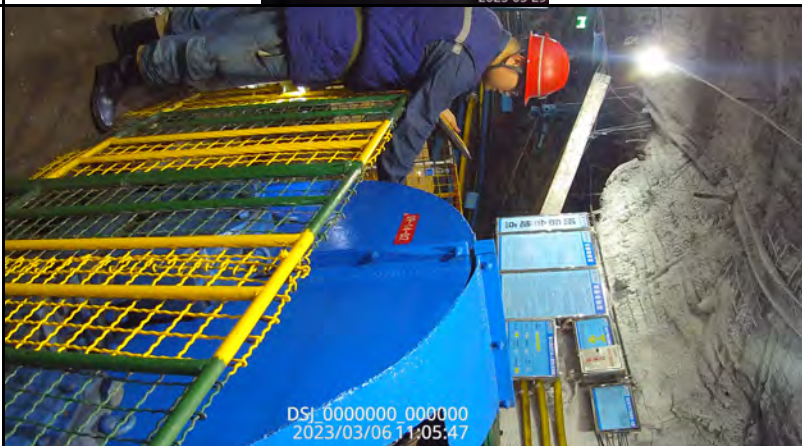
<p>2023 03 29</p>
215	GX-B1515/22-6-23003	2023/4/20	所检项目合格
