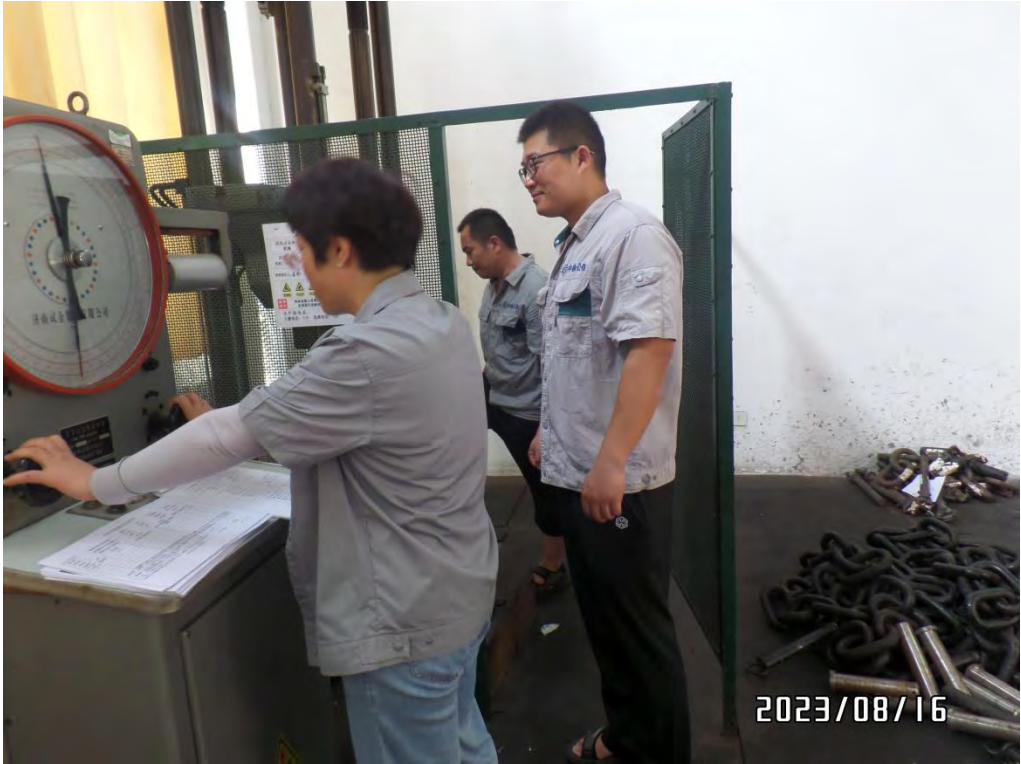
序号	报告编号	发布日期	结论	影像资料
250	GX-B1365/20-A-23062	2023/8/24	所检项目全部合格。

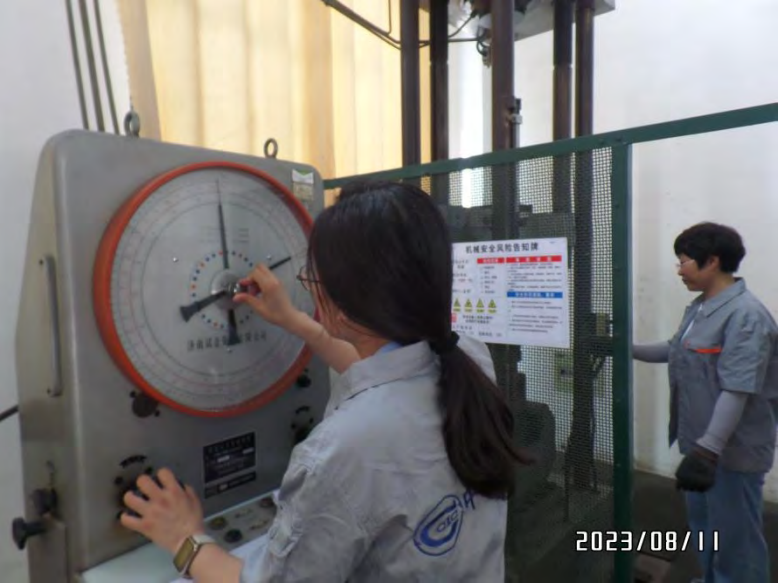
序号	报告编号	发布日期	结论	影像资料
275	GX-B1369/20-A-23008	2023/8/31	所检项目合格。
